SIO Shipyard Representative Bi-Weekly Progress Report		
<b>Project: AGOR 28</b>	<b>Contract No.: N00014-12-C-0305</b>	<b>Shipyard: Dakota Creek Industries</b>
<b>Prepared by:</b> Paul D. Bueren Scripps Institution of Oceanography (SIO) 297 Rosecrans St. San Diego, CA 98106	<b>Date:</b> 8 April 2016	<b>Program Officer:</b> Robert (Tim) Schnoor Office of Naval Research 875 Randolph St ONR 321 Arlington, VA 22203-1995
<b>Distribution Statement A:</b> Approved for public release; distribution unlimited.		<b>Report No. A002.097</b>

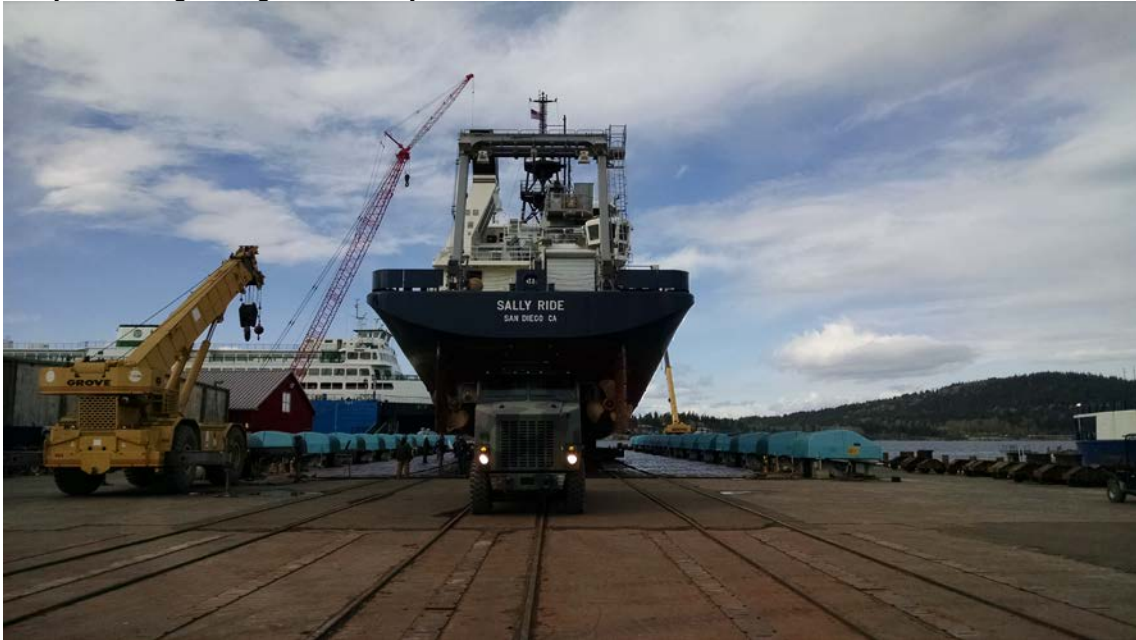
- Phase III Haul-out – Sally Ride was scheduled to be on the synchro-lift on 1 April, put due to a delay in floating a barge on the ways, she was hauled out on the afternoon of the 8<sup>th</sup>.

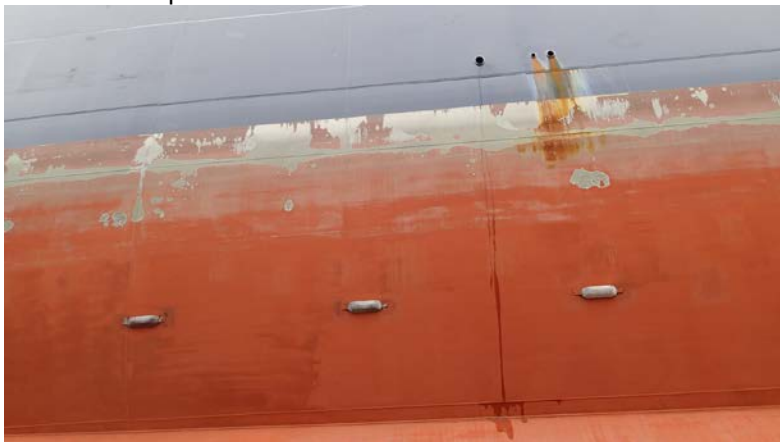
- Underwater Coatings – The International paint rep was on site and walked the ship with DCI's paint foreman. There is 3-foot wide strip of AF failure on the port side and 4 or 5 softball size patches on the starboard side. The yard will fix these per International Paints recommendations. The yard will provide Internationals report to us. In addition, AF will be applied to the tail shafts as requested. The yard will then do a full coat of AF on the hull, including any touch up required for the bilge keel and other mods.

Example of Port Side AF Failure

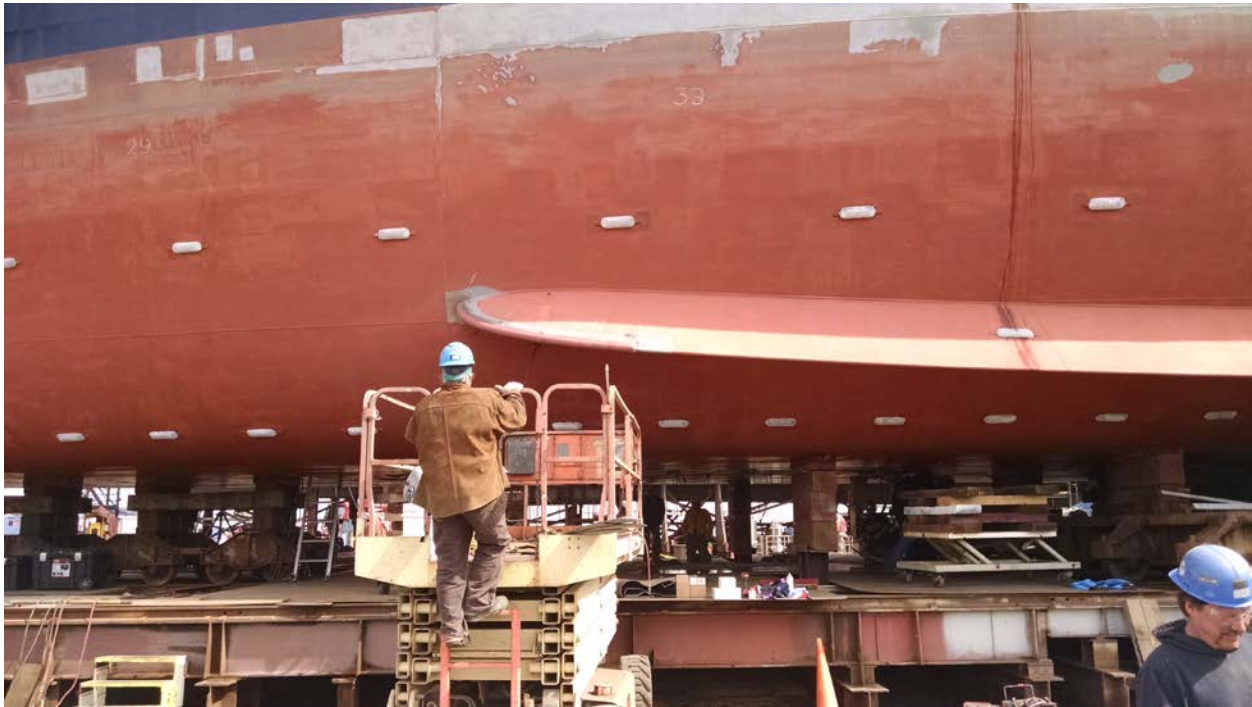
Example of port side AF repair. Painters are sanding and fairing in affected areas at the waterline.

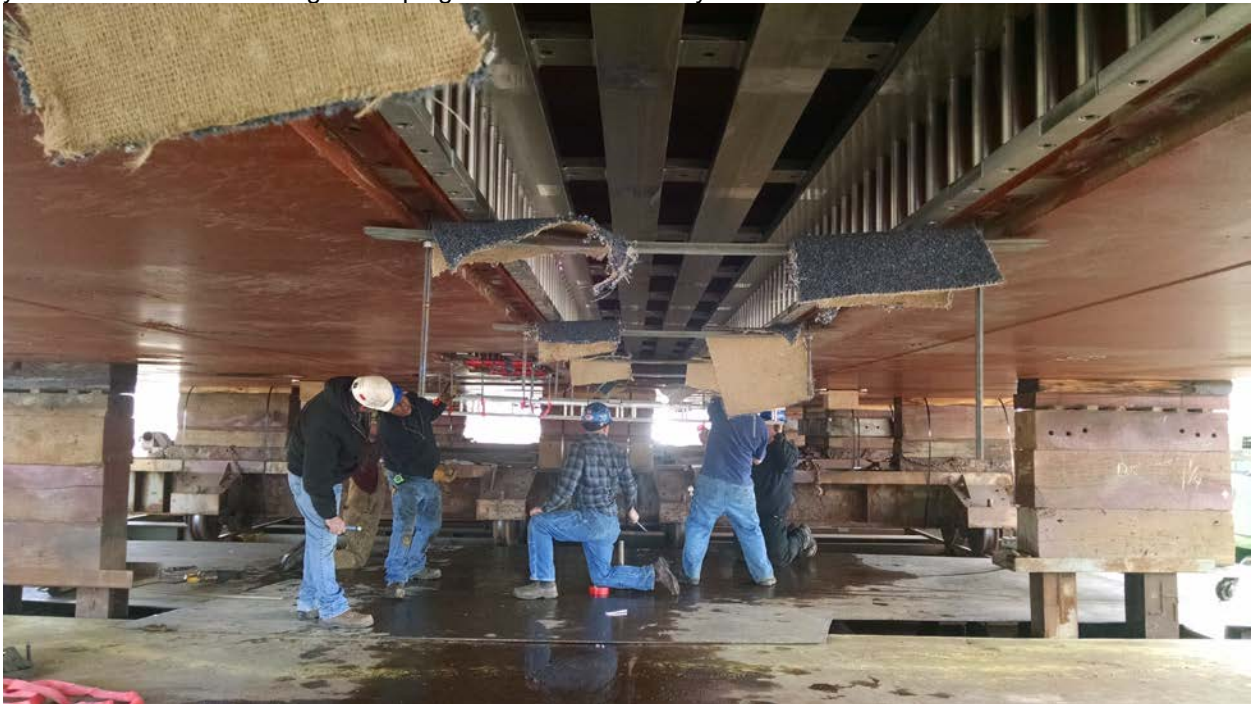
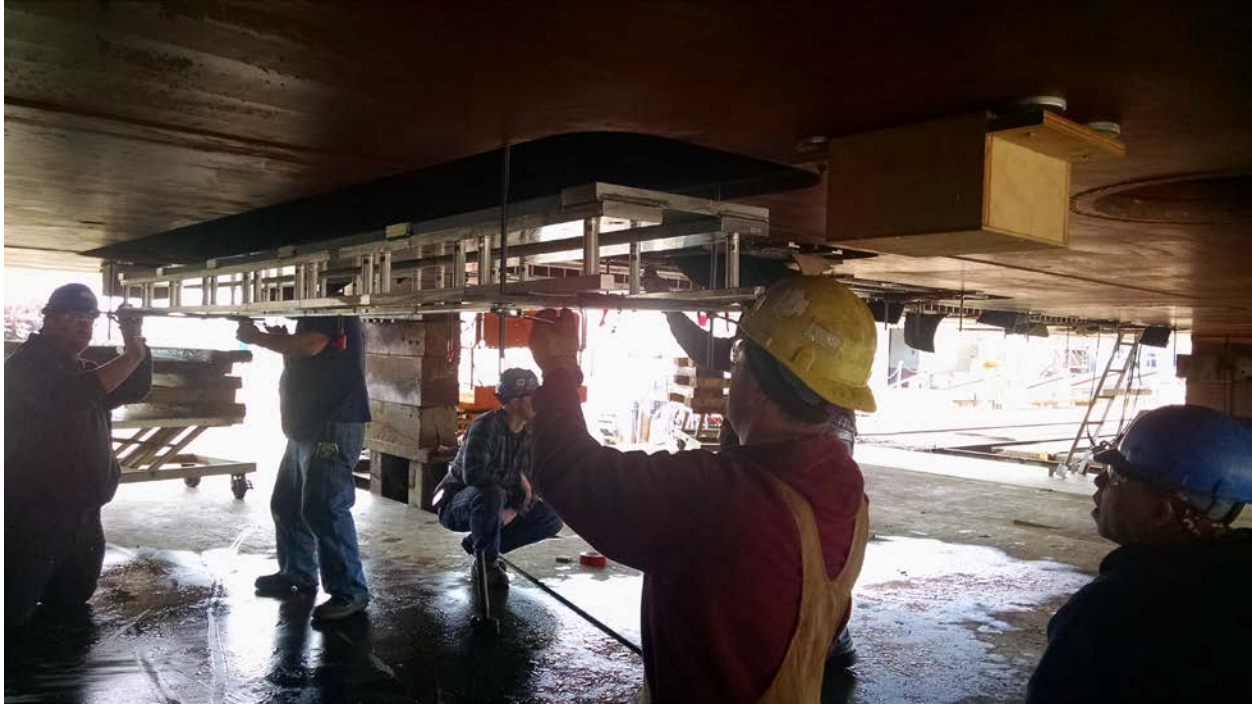
- Bilge Keel Mod – DCI is in the process of fitting and welding the new section to the bilge keels. See above picture.
- EM122 and EM712 Frames – The frames have been surveyed in and clamped into place. The yard will commence drilling and taping the holes on Monday.

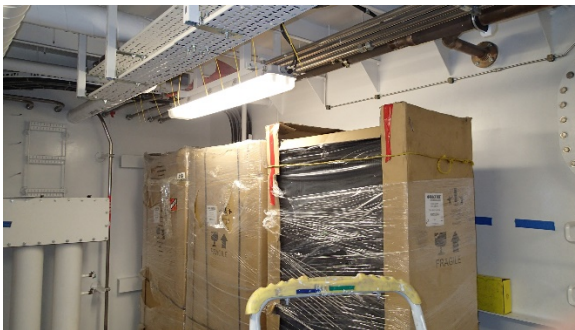
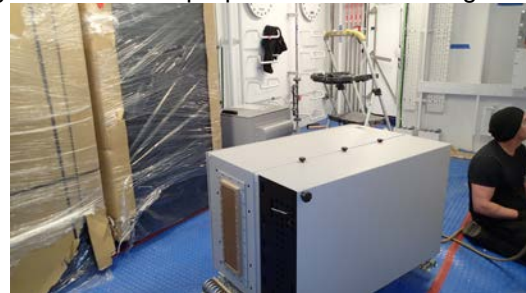
- Transceiver Room – Rack and Kongsberg Equipment have been staged for installation in the transceiver room. Outside machinists are drilling foundations in preparation for mounting.

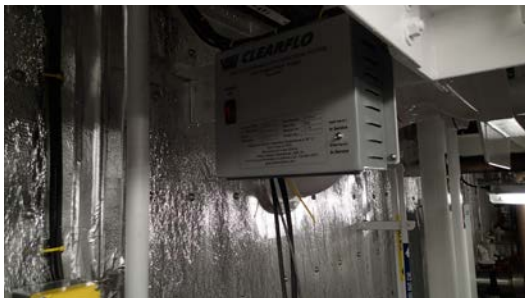
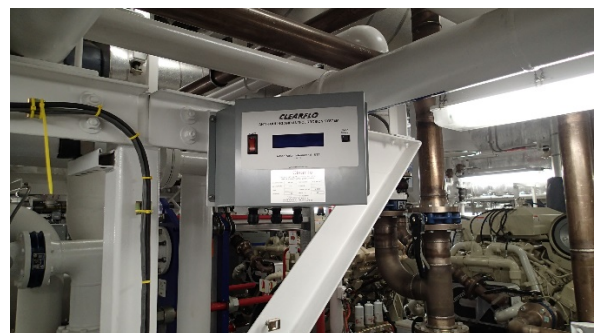
- Sea Chest Anti-Bio Fouling System WP10 – The yard has installed the electrical components and is in the process of making the interconnects to the Remote Display and the two Power Unit/Controllers.

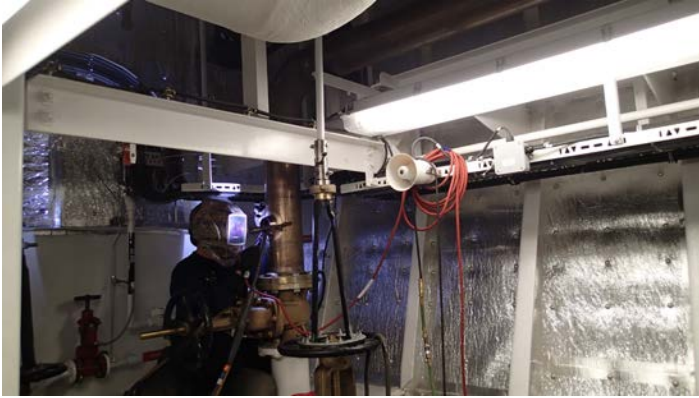
- Fire Pump Sea Chest Deicing Line - The piping has been run by the fitters and the joints are being welded.

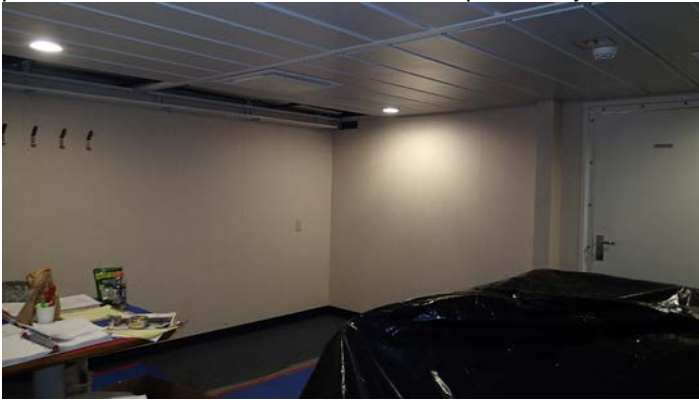
- Cable Transit – An additional cable transit was required to accommodate the large number of cables being run between the transceiver room and computer lab. The yard is taking care to protect the furniture, bulkheads and carpet in way of the cutting and welding.

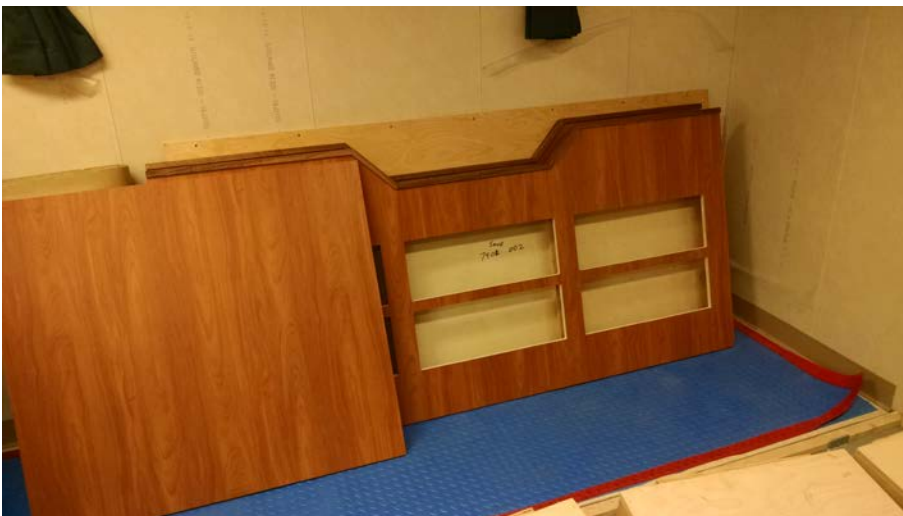
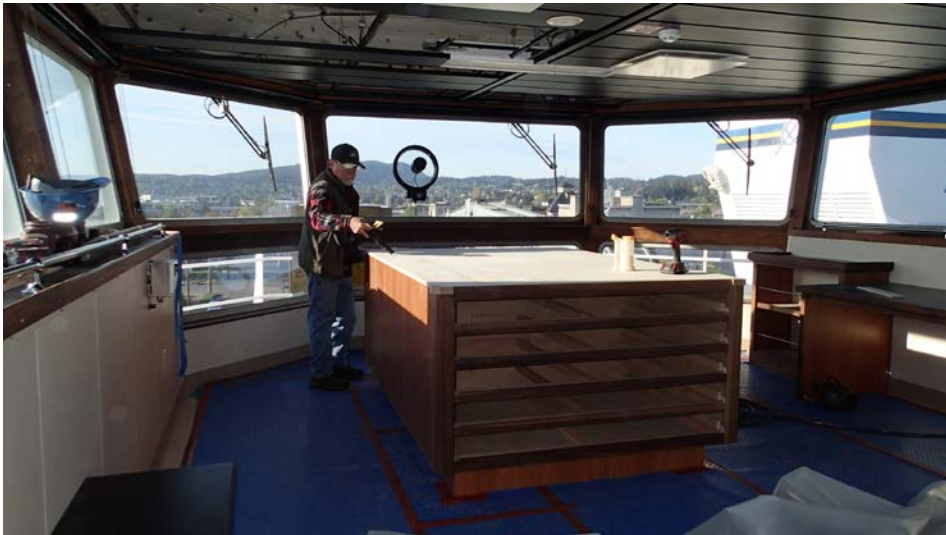
- Furniture Configuration Change - The hospital bunk is being raise to allow for better ergonomic patient care. An additional row of drawers has been added. A double chart table and desk are being installed in the Pilot House.

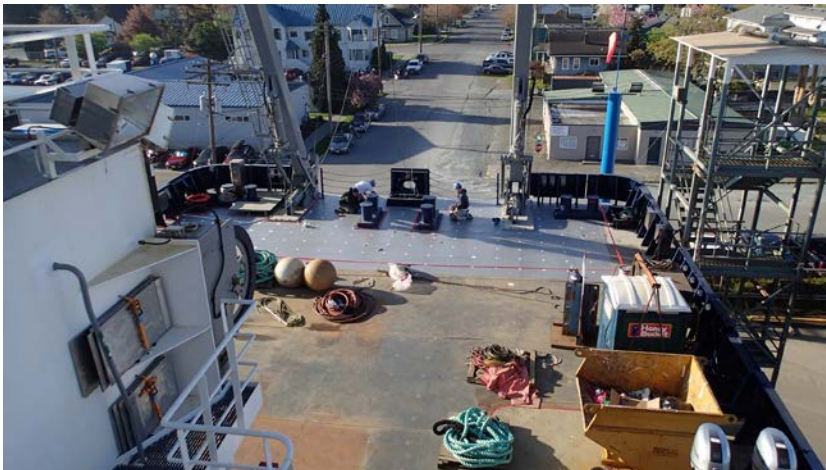
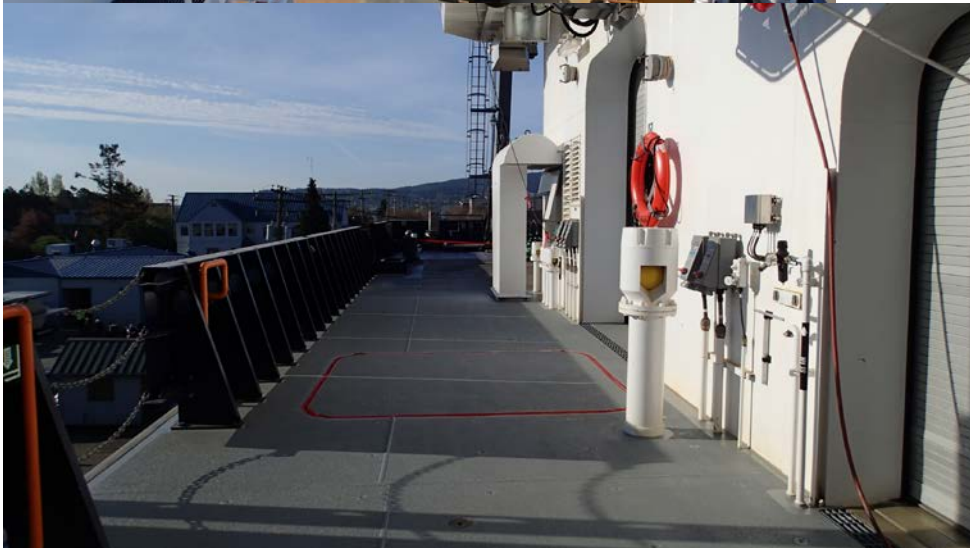
- Topside Paint – Painters are making hay while the sun shines. Where necessary, they are going down to bare metal prior to coating.
